213 Hart Street
 Corner Hart Street & High Road
 1774
 Josiah Atwood (1740-1804) & Huldah

1985 Townwide Historic and Architectural Survey of Berlin, Connecticut. Survey # 052

HISTORIC RESOURCES INVENTORY
BUILDING AND STRUCTURES
 HIST-6 NEW 5/77

IDENTIFICATION	
1. BUILDING NAME (Common) <u>#052</u> (Historic)	
2. TOWN CITY <u>Berlin</u>	VILLAGE <u></u> COUNTY <u>Hartford</u>
3. STREET AND NUMBER (and/or location) <u>213 Hart Street</u> <u>8-3/53A/1</u>

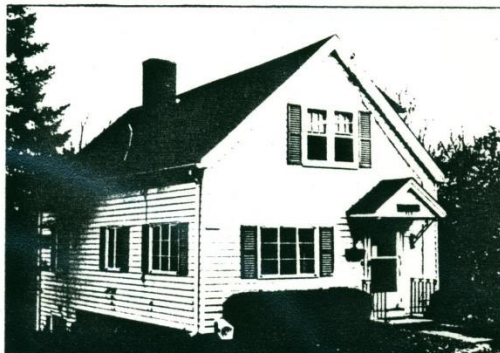
PHOTO

This house displays little old or original exterior fabric. The ridge of the house runs east-west, parallel to Hart Street; to the rear (east), the lot slopes away steeply, exposing the original fieldstone foundation. The modern entry under a recent shelter is located in the right bay of the west elevation; to the left is a modern picture window; above are paired attic lights. All sash is recent. Original cornice detailing is obscured by modern siding. The north elevation has three recent windows and a recent brick chimney below the ridge of the roof. The south elevation has a cross-gable ell; the east elevation has a rear, framed-in, one-story bay extension.

Although it displays little original fabric (with the exception of the old or original fieldstone foundation), this house is significant as a surviving 18th-century house. Few original characteristics are visible from the exterior, but the scale and the ridge-parallel orientation reflect its early origin.

SE
